LANAUGCIH1400

Installation Instructions

Auger Extension for 14" Diameter CASE IH Combine Augers
7010 & 8010: 2006 & OLDER, 5088-9240: 2009 & NEWER Combines

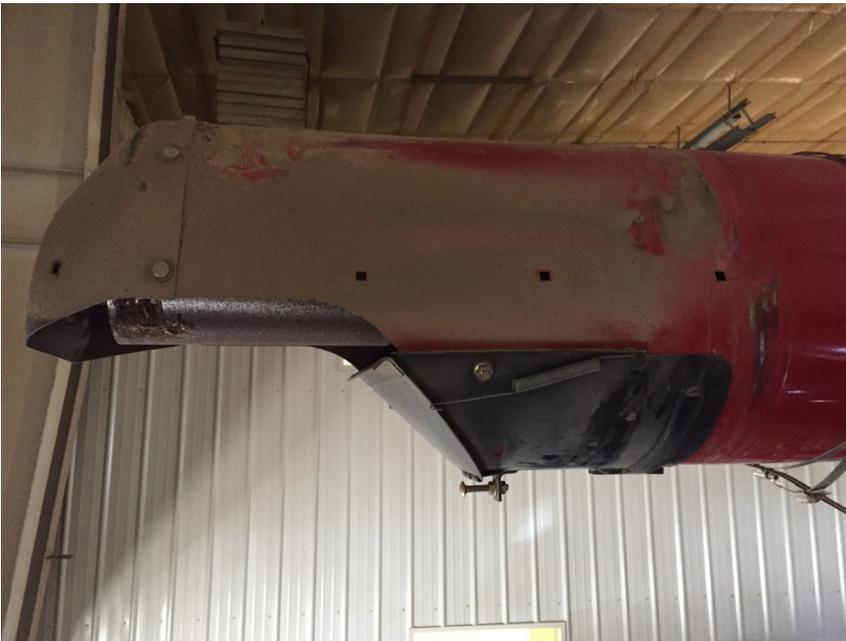
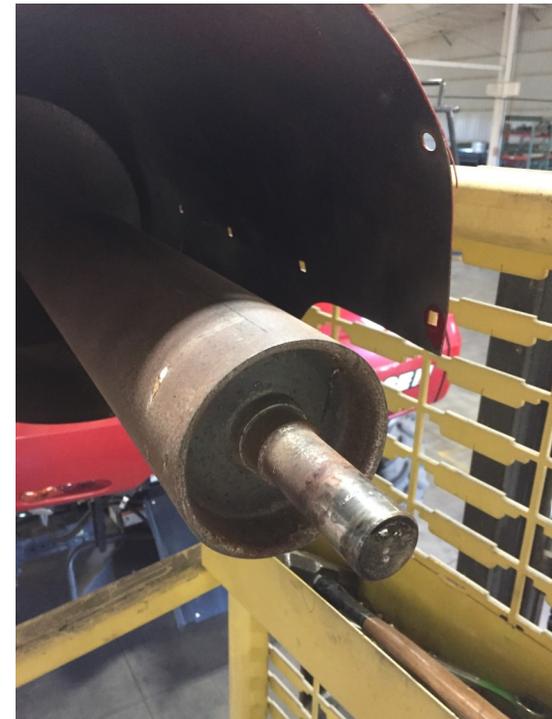
{ Figure 1.1 }

1.1 Remove the rubber boot, cap, bearing, and grain saver door from the end of the factory auger tube.

Refer to Figures 1.1 and 1.2

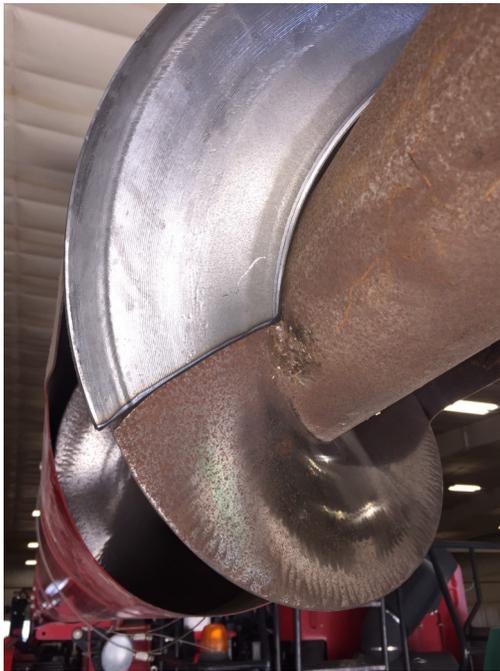
Figure 2.1

2.1 Remove the rubber boot, cap, and bearing from the end of the factory auger tube.

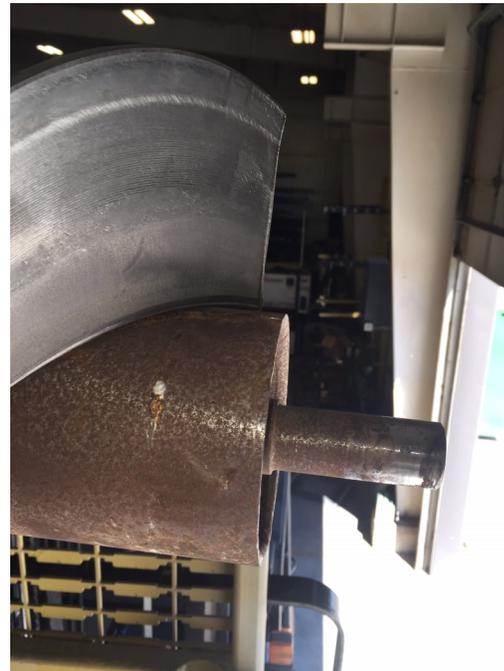
Figure 2.2

2.2 Trim the provided auger flighting (LANAUGCIH1403) to fit up against the factory one. Next, trim the flighting so that no part of it comes within 1/2" of the end of the auger shaft. Weld the two pieces of flighting together and stitch weld the new piece to the auger shaft

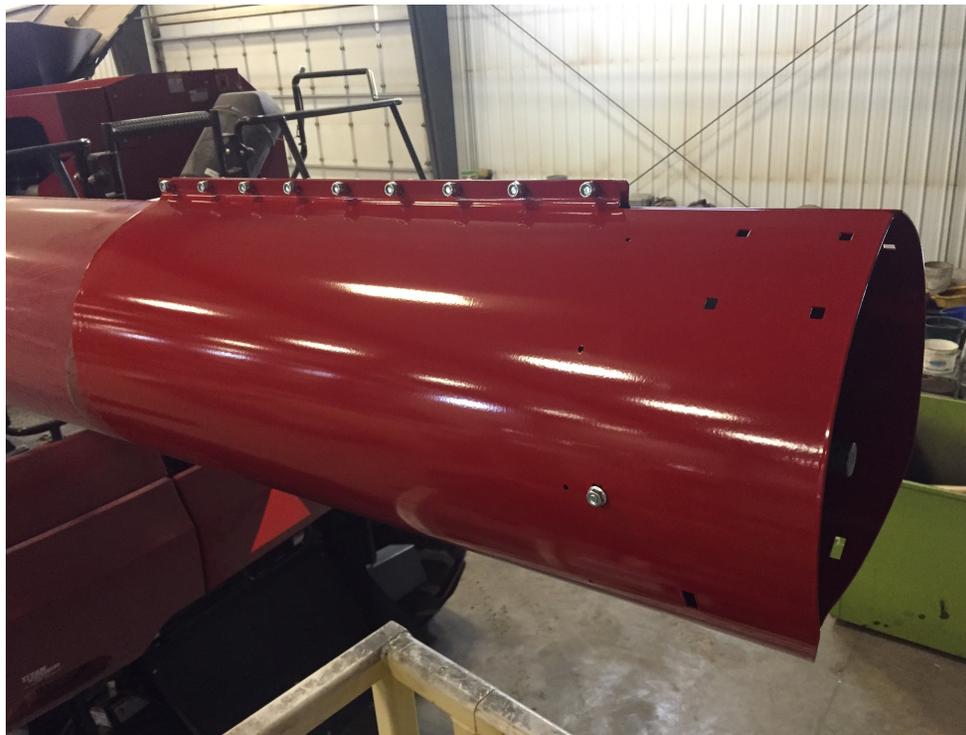
Figure 3

3.1 Wrap the Auger Extension Sleeve (LANAUGCIH1401) around the existing auger tube and use two 5/16" x 1/2" carriage bolts (LANFK202) and two 5/16" flange nuts (LANNAS2) to bolt the sleeve to the factory auger tube. Make sure the bolt head is to the inside of the auger tube. Leave these fasteners loose at this time.

3.2 Install nine 3/8" x 1.25" carriage bolts (RED305K) and nine 3/8" nyloc nuts (LAN1618000) in the upper flange of the Auger Extension Sleeve. Snug all of these up incrementally until the sleeve is tight on the factory auger tube.

3.3 Tighten the 5/16" fasteners at this time.

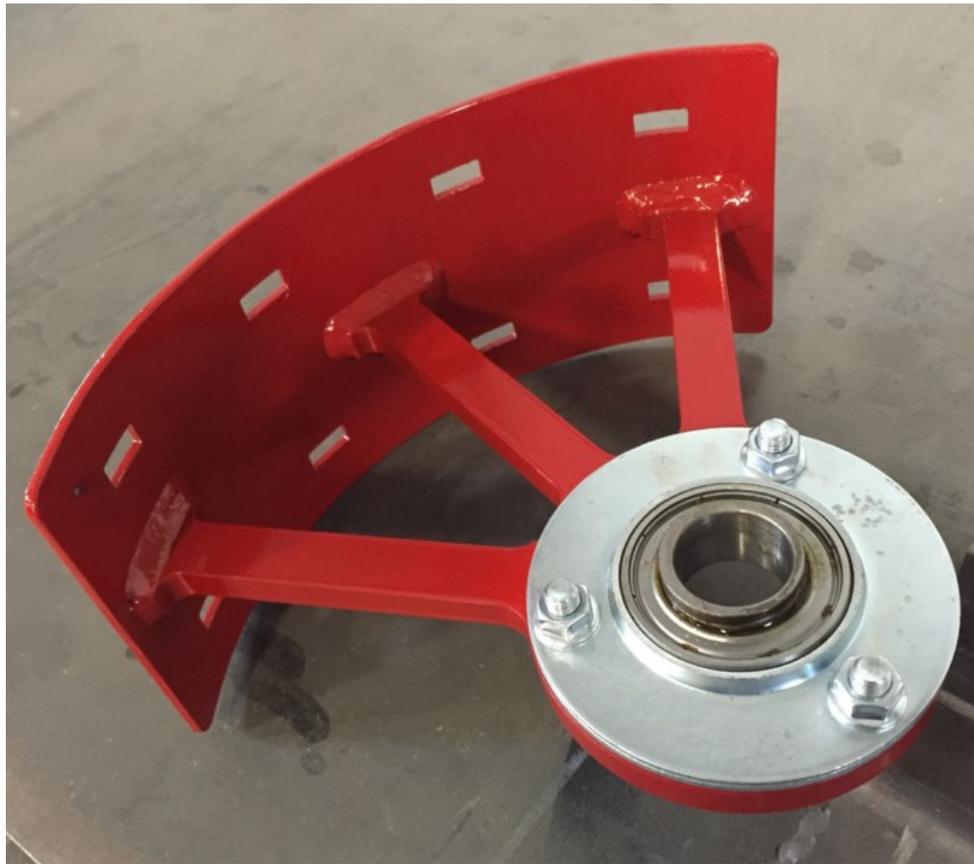
Figure 4

4.1 Using three 3/8" x 1.25" carriage bolts (RED305K) and three 3/8" flange nuts (LAN3718), bolt the bearing (LANSA206) and two bearing flanges (RED34012) to one side of the bearing hanger (LANAUGCIH1402) as shown below. Make sure the locking portion of the bearing is on the same side of the hanger as the flanges as well as the grease zerk.

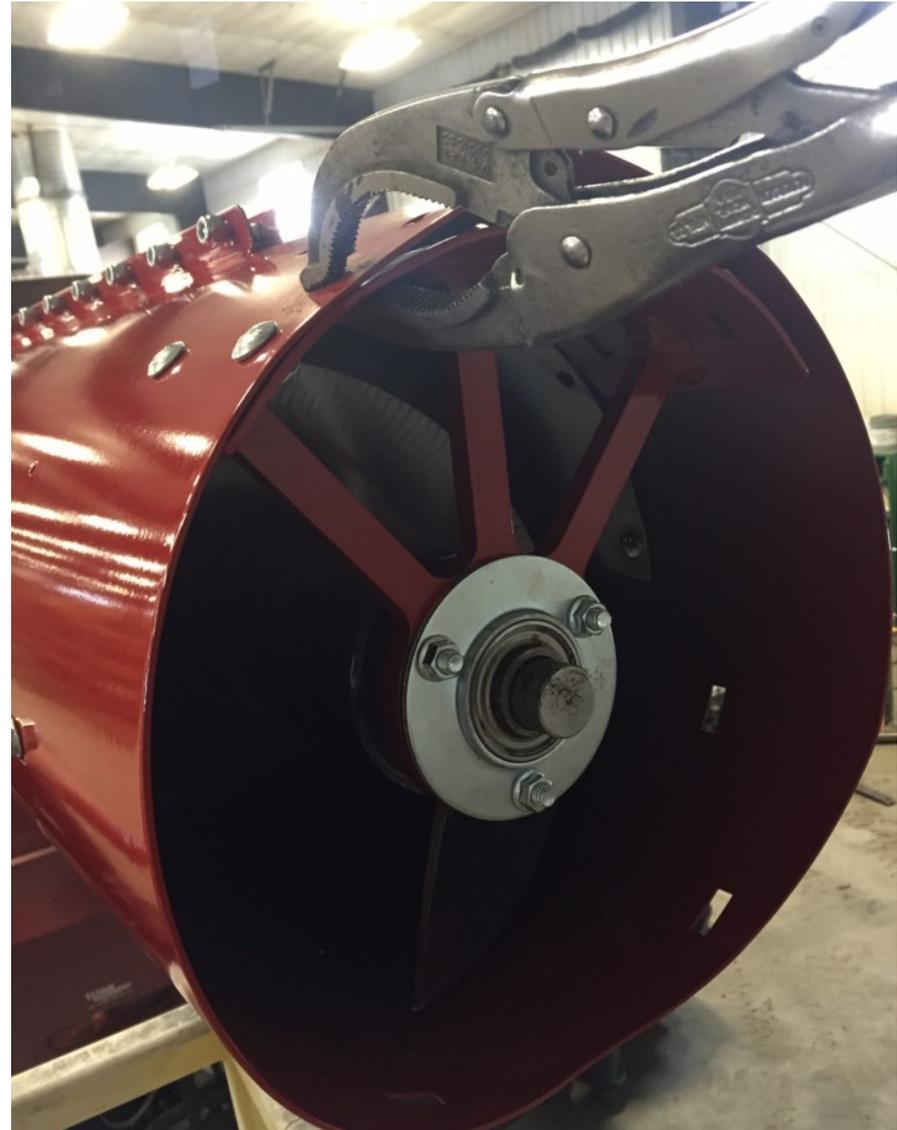
Figure 5

5.1 With the flanges toward the end of the auger, slide the bearing over the shaft of the existing auger until the slots in the bearing hanger (LANAUGCIH1402) line up with the slots in the auger extension sleeve (LANAUGCIH1401).

5.2 Using a clamp to hold the bearing hanger up to the extension sleeve, install all eight 5/16" x 1/2" carriage bolts (LANFK202), with the 5/16" flange nut (LANNAS2) to the inside of the tube.

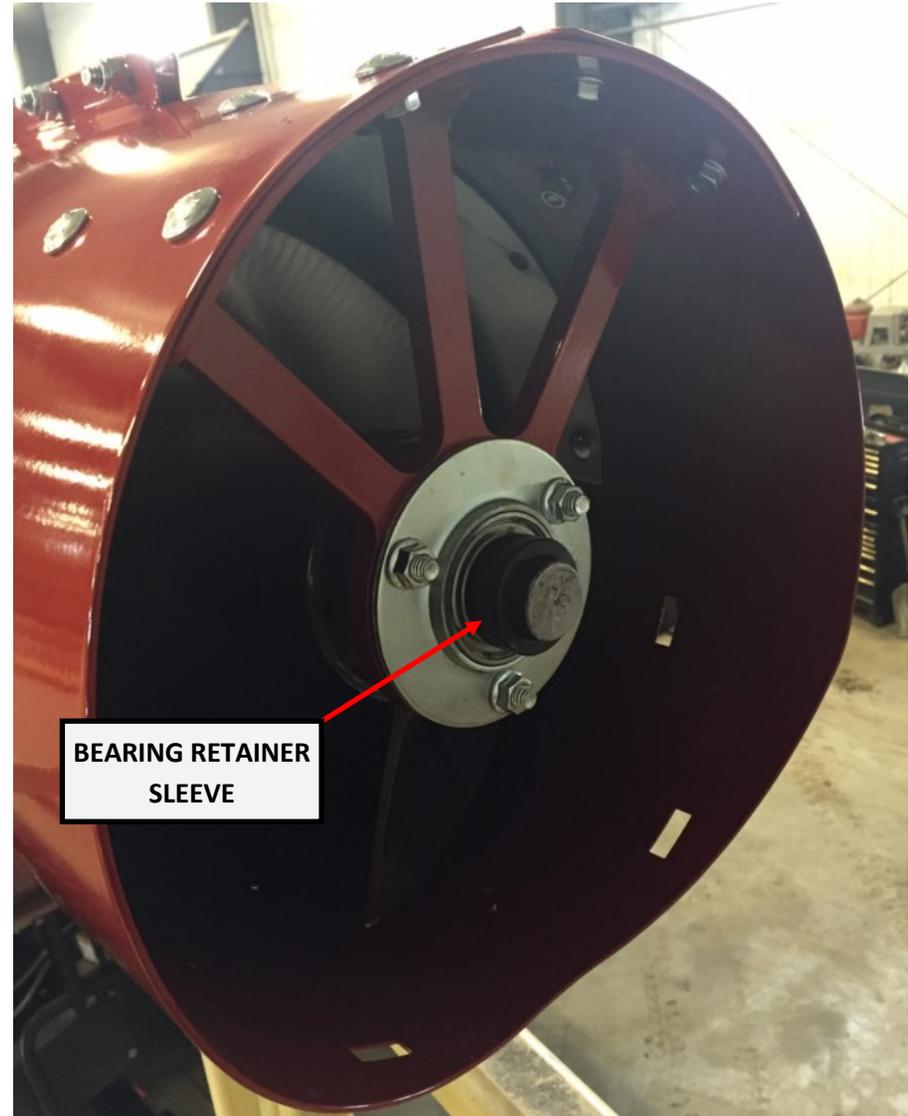
Figure 6

6.1 Make sure the entire auger is pushed all the way into its splines on the other end (covering the end of the shaft with a block of wood and hitting it with a hammer works well).

6.2 Install the bearing retainer sleeve. This will keep the auger from sliding out from this point forward.

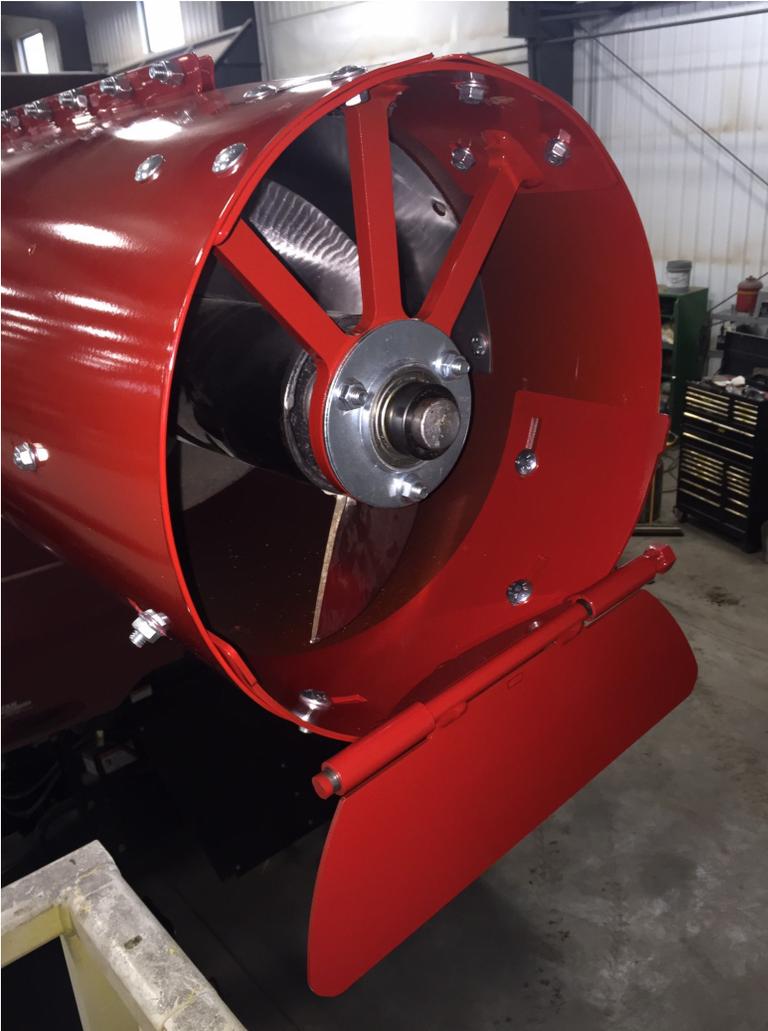
Figure 7.1

7.1 Install the grain saver door (LANC14GS00) using four 3/8" x 3/4" carriage bolts (LANFK303) and four 3/8" flange nuts (LAN3718). The bolt head should be on the inside of the tube.

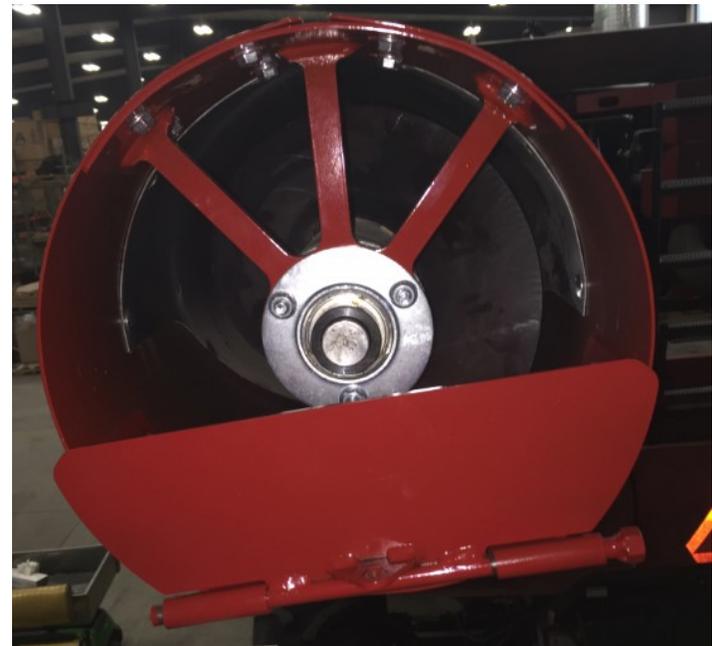
Figure 7.2

7.2 The grain saver door should be slid to the right in the bolt slots as much as possible. This will allow it to sit at the proper angle when the auger is unloading.

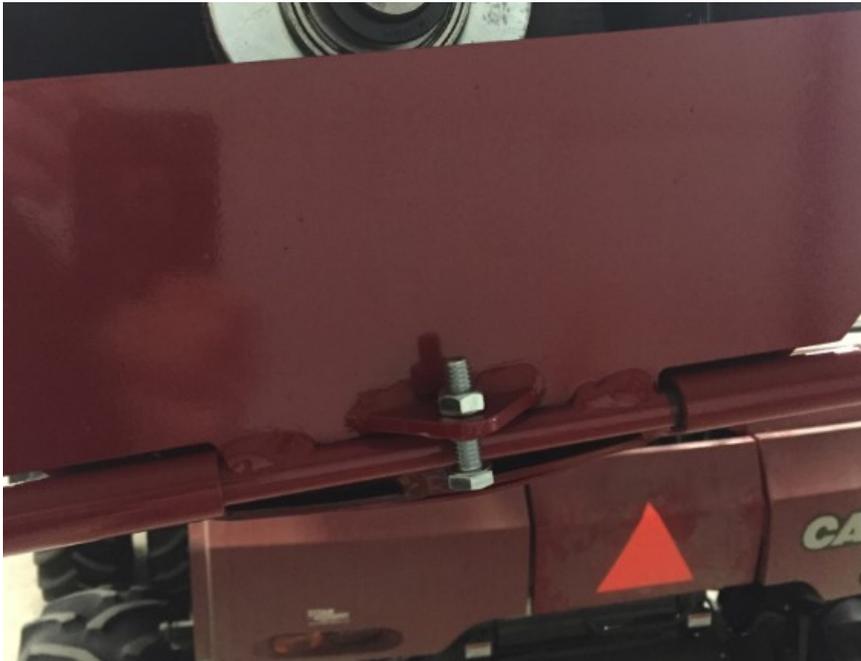
Figure 8.1

8.1 Install the 5/16" x 1.25" bolt (LAN3B16A16) and hex nut (LANF-HN-0.313C) in the grain saver door with the head of the bolt to the bottom and the nut on the top.

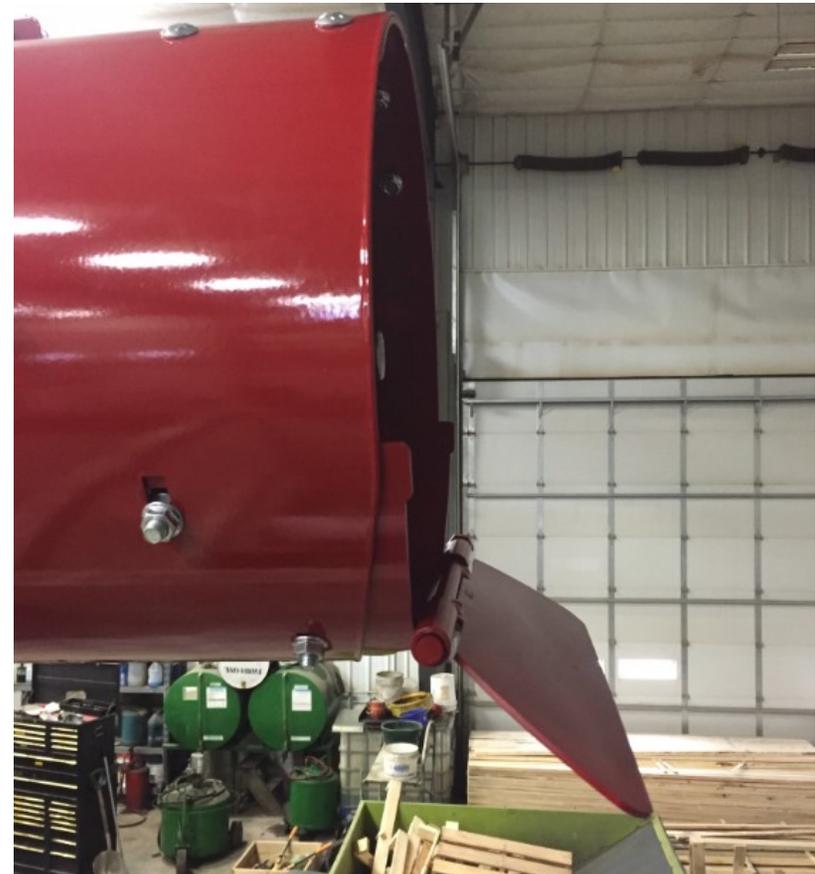
Figure 8.2

8.2 Set the bolt so the door will open about 30 degrees below horizontal. This acts as a stop so the grain saver door spring is not over extended.

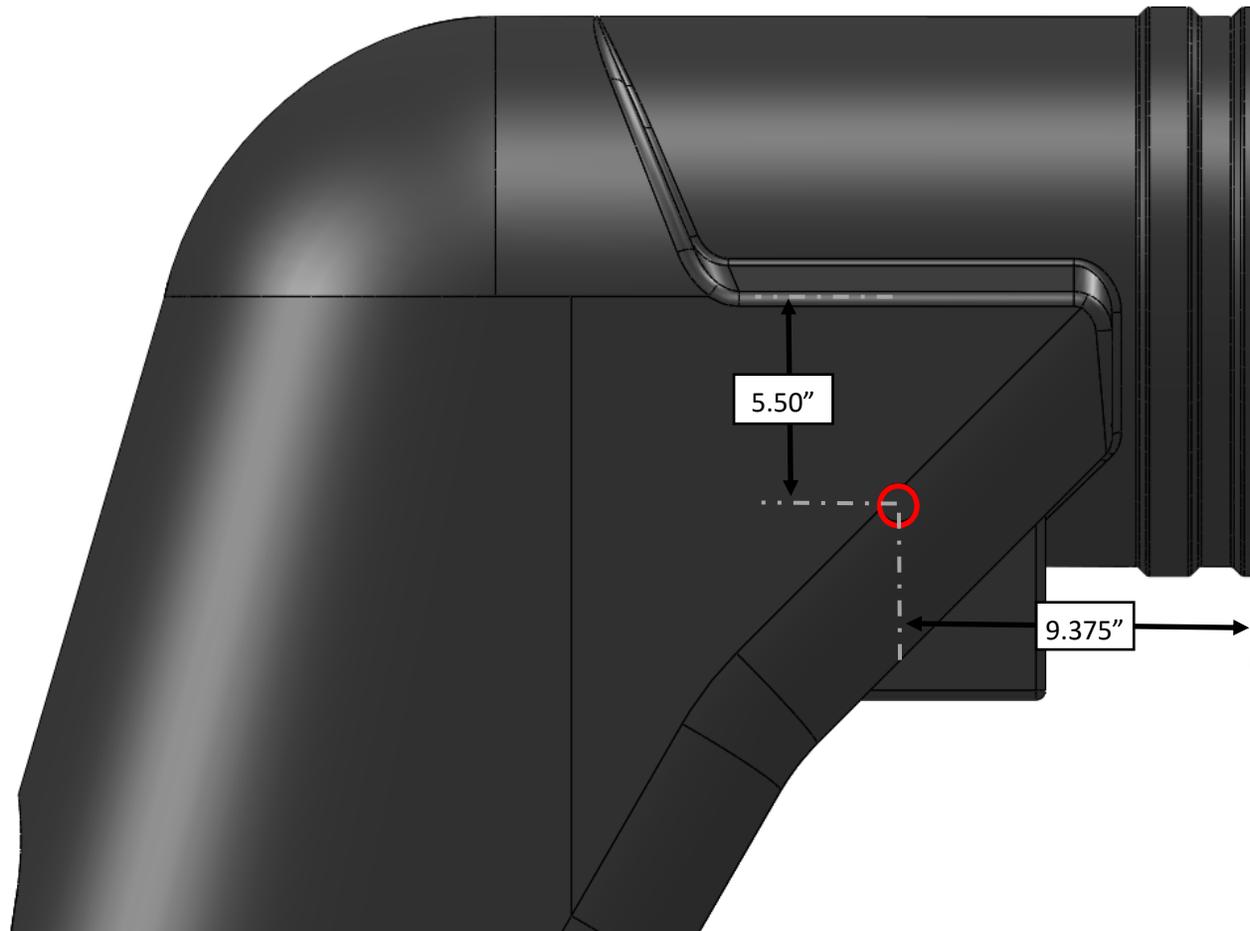
Figure 9

9.1 Mark out and drill a 5/8" hole 9.375" from the back of the spout (CASE IH part #84219375) and down 5.50" from the bend.

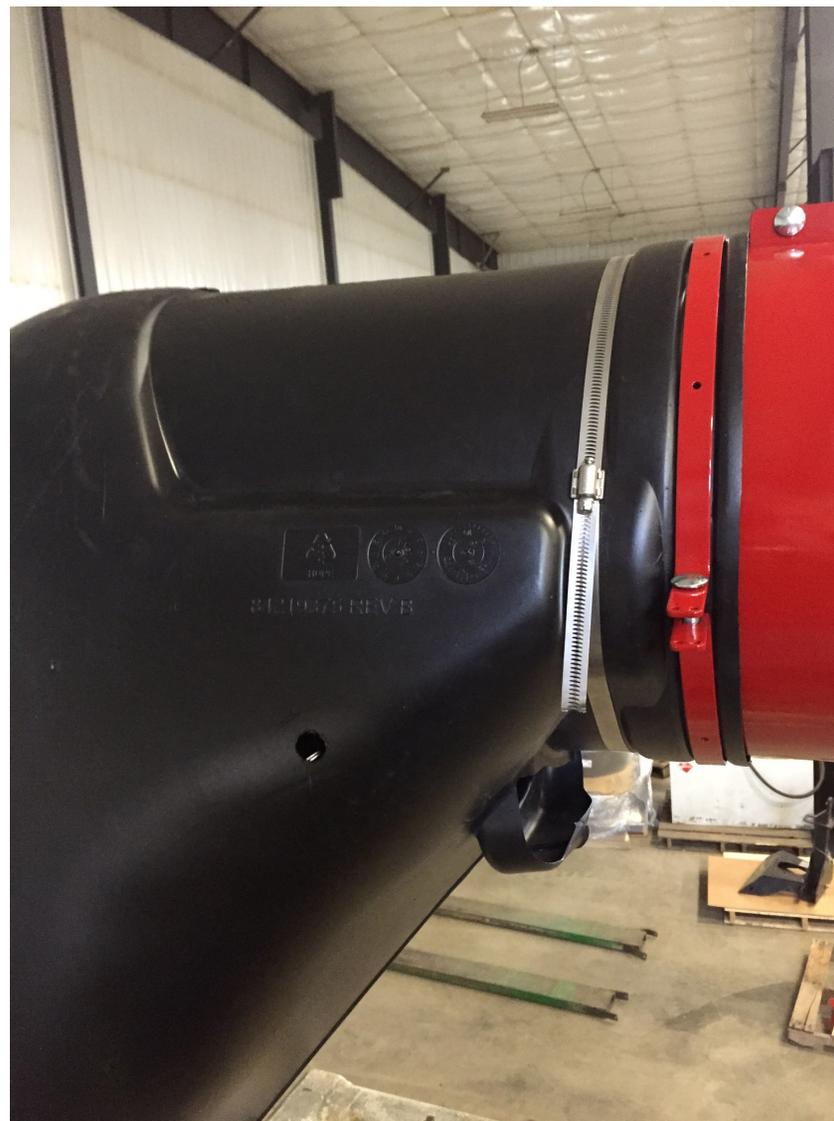
Figure 10

10.1 Install the plastic spout (CASE IH part #84219375) over the end of the auger extension and slide back until the spout hits the top flange of the saddle tube (LANAUGCIH1401).

10.2 Place the two half bands (LANC14GS04) over the back half of the spout and start two 3/8" x 1.50" carriage bolts (LAN18A32) with two 3/8" nylon insert nuts (LAN1618000). Leave loose at this time.

10.3 Install the spout clamp (LANHK4X7) in front of the half bands that were previously placed. Leave loose at this time.

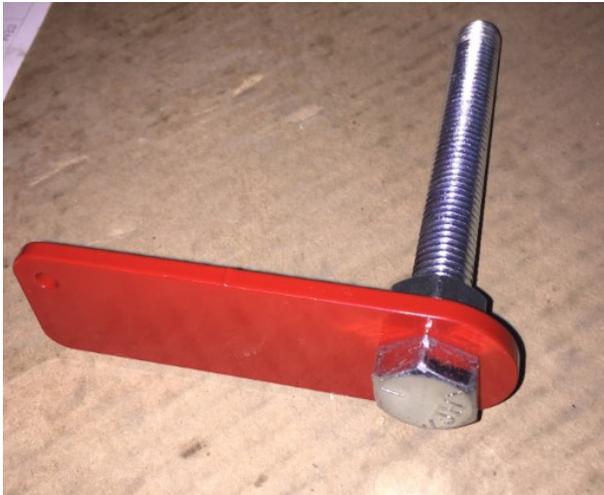
{ Figure 11.1 }

11.1 Place the 1/2" x 4.5" bolt (LANF011G) through the spring arm (LANGS24) and thread on the 1/2" hex nut (LANF-HN-0.500C). Make sure the small hole in the spring arm is to the right side when looking at the head of the bolt. Leave the nut loose at this time.

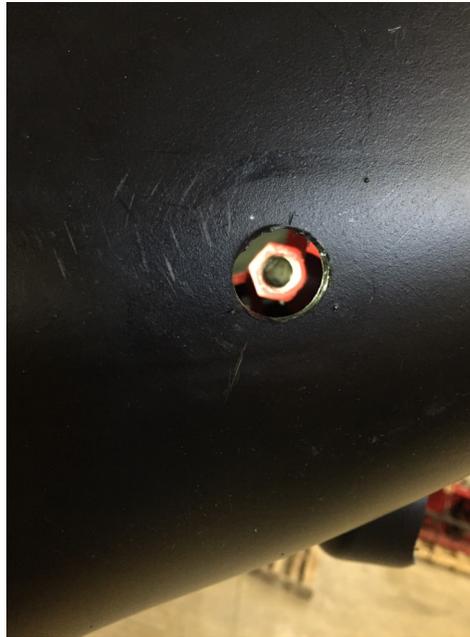
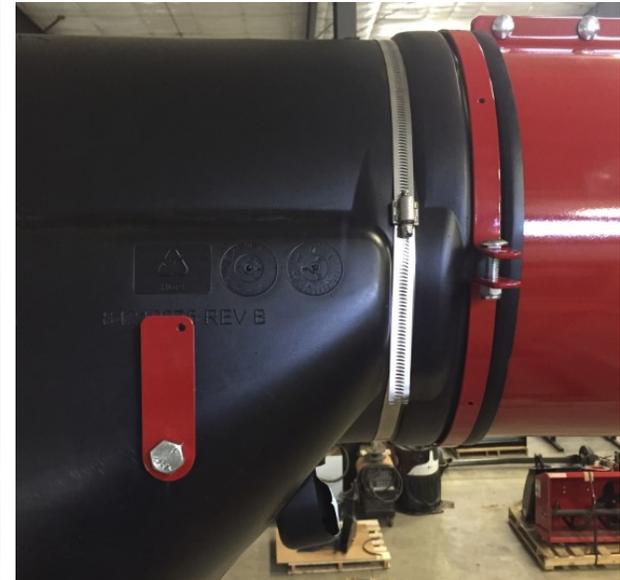
11.2 Make sure the hole in the spout is lined up with the welded nut on the grain saver door hinge. Install and tighten the 1/2" bolt through the hole in the spout. The half bands and spout clamp may now be tightened up.

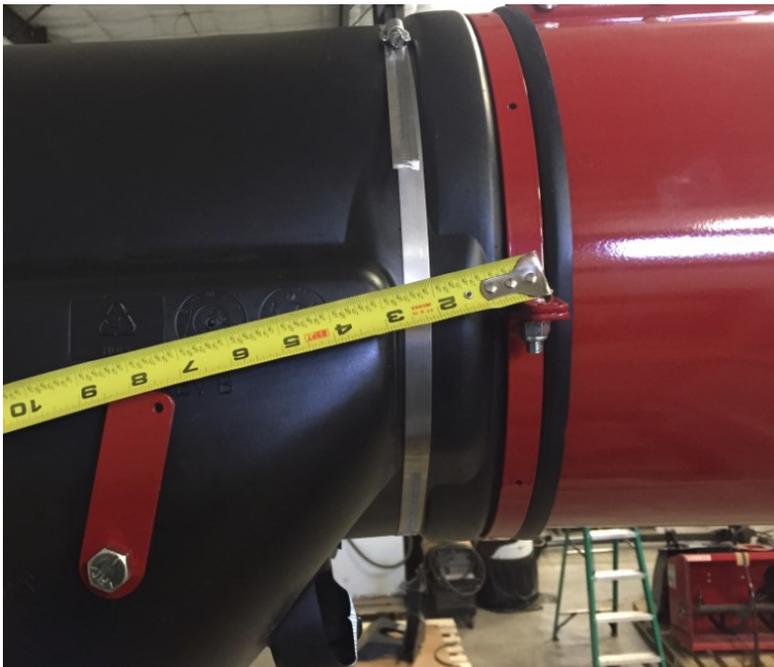
Figure 12.1

12.1 Adjust the angle of the spring arm so it tilts about 10-15 degrees back from vertical. The distance between the closest holes on the half band and spring arm should be about 8.0". Adjust the half band's rotation on the tube to achieve this. Tighten the 1/2" nut to lock the spring arm in place.

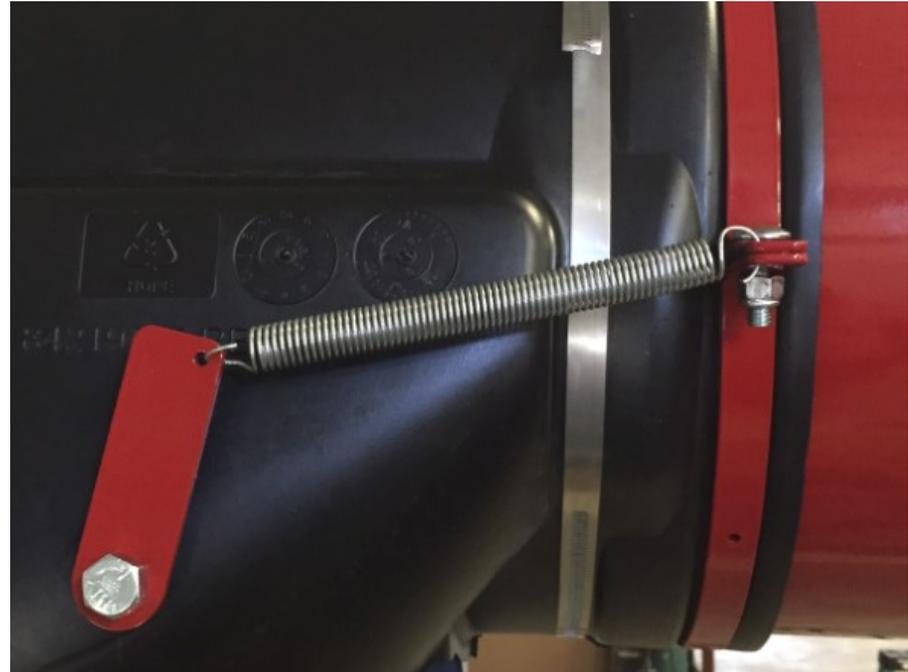
Figure 12.2

12.2 Install the spring (LANH217334) from the half band to the spring arm. Make sure the spring moves freely as the grain saver door opens up to its stopping point.

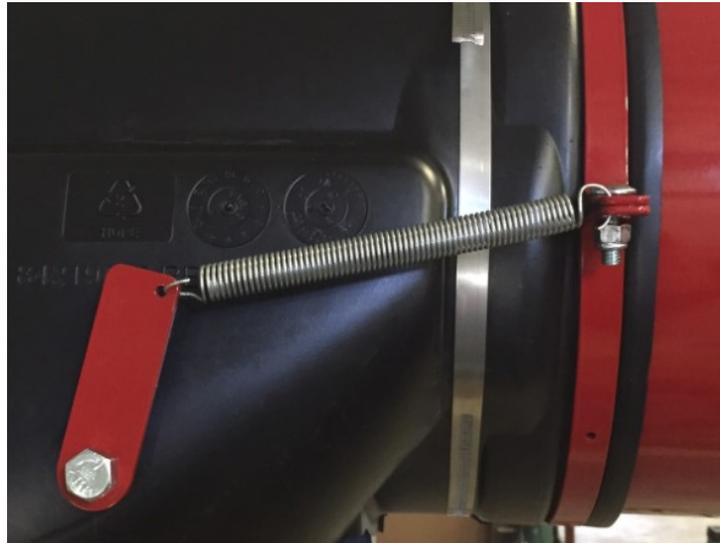
{ *Figure 13.1* }

13.1 The measurements given to set the grain saver door stop bolt, spring arm, and half band are a very good starting point for proper grain saver door starting point, but they can be adjusted if necessary. Some important things to keep in mind are:

1. There should always be spring force on the grain saver door when closed
2. The force used to hold the door open should be less than when the door is closed.
3. The door should always be able to return to the closed position without assistance.

When tuned correctly, grain should flow out of the tube as normal and, when the auger is shut off, will drain for a second or two, at which point the grain saver door should close sharply.
